# MAUCH CHUNK LAKE DAM

PHASE I INSPECTION REPORT  
NATIONAL DAM INSPECTION PROGRAM

SEPTEMBER 1978

MAUCH CHUNK LAKE DAM  
CARBON COUNTY, PENNSYLVANIA  
NATIONAL I.D. NO. PA 00605

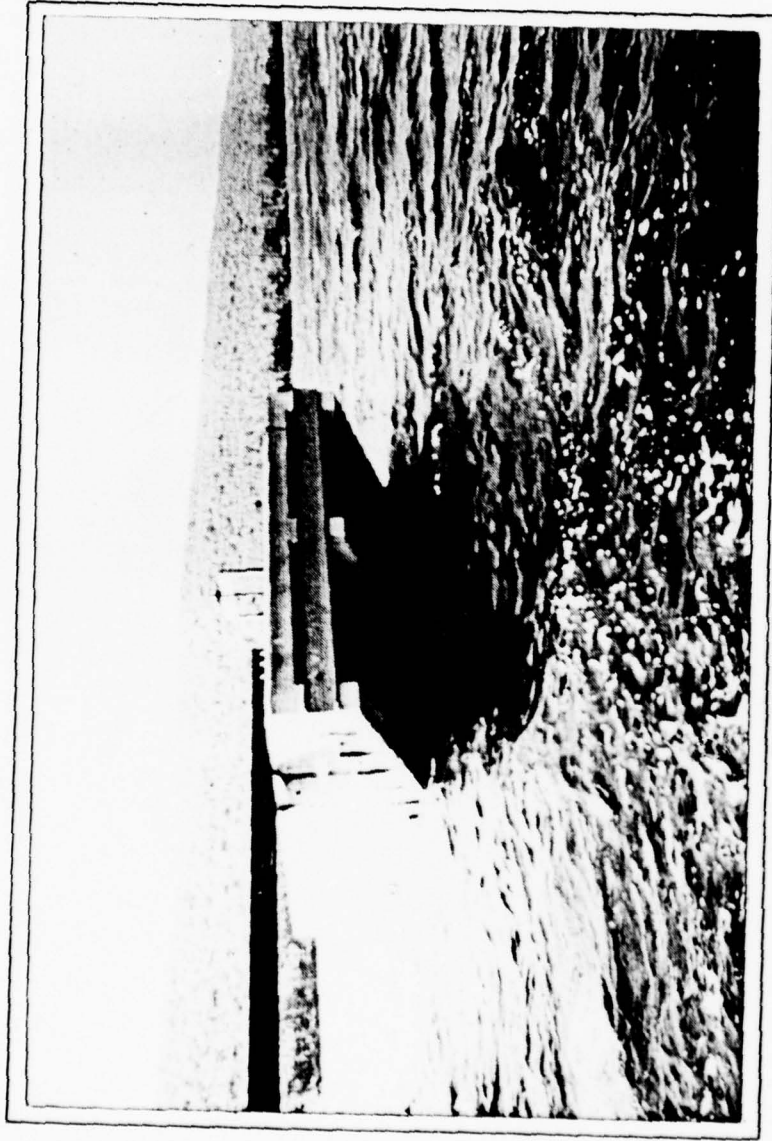
PHOTOGRAPH NO. 1

PRINCIPAL SPILLWAY

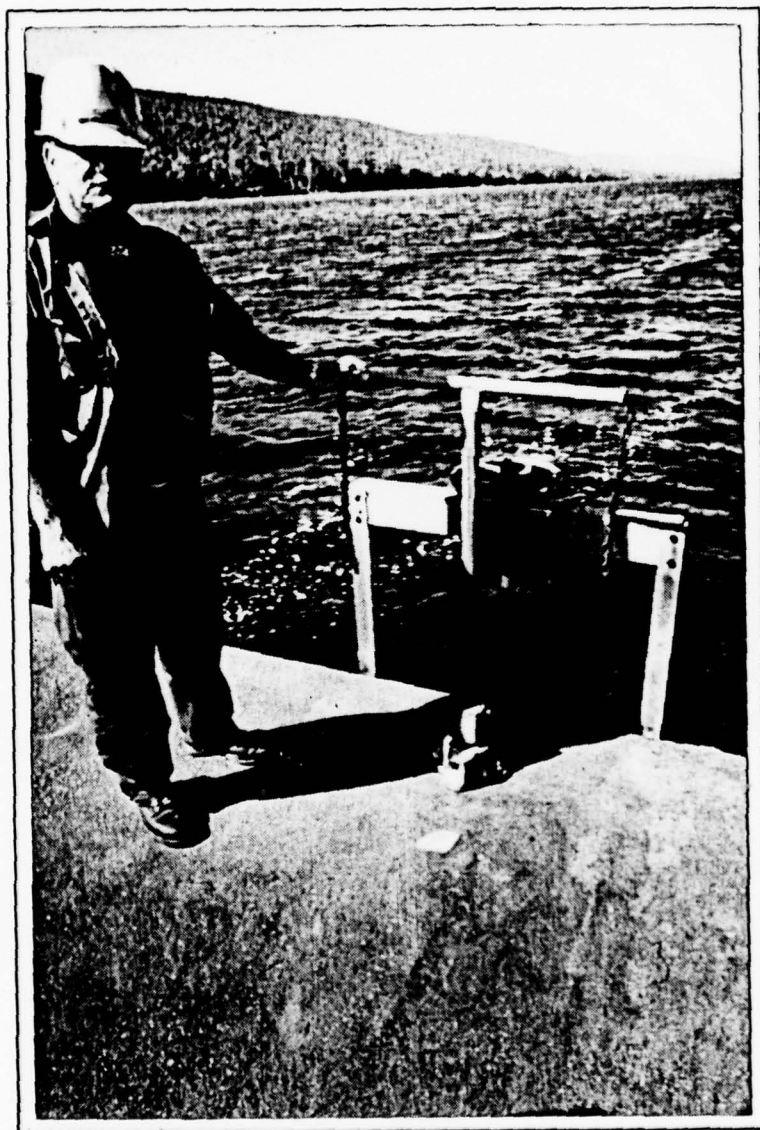
PHOTOGRAPH NO. 2

1. Principal Spillway. The exposed portions of the principal spillway are in excellent condition, with no signs of cracked or spalled concrete. All gates were exercised and appeared to be in good condition. The gate valves for both the pond drain and water supply pipes were painted, clean and well lubricated. An operations and maintenance manual is located in the Park Office files. The pond drain valve was manufactured by Armco, Model 22505A.

POND DRAIN VALVE LOCATED  
ON TOP OF PRINCIPAL SPILL-  
WAY RISER.

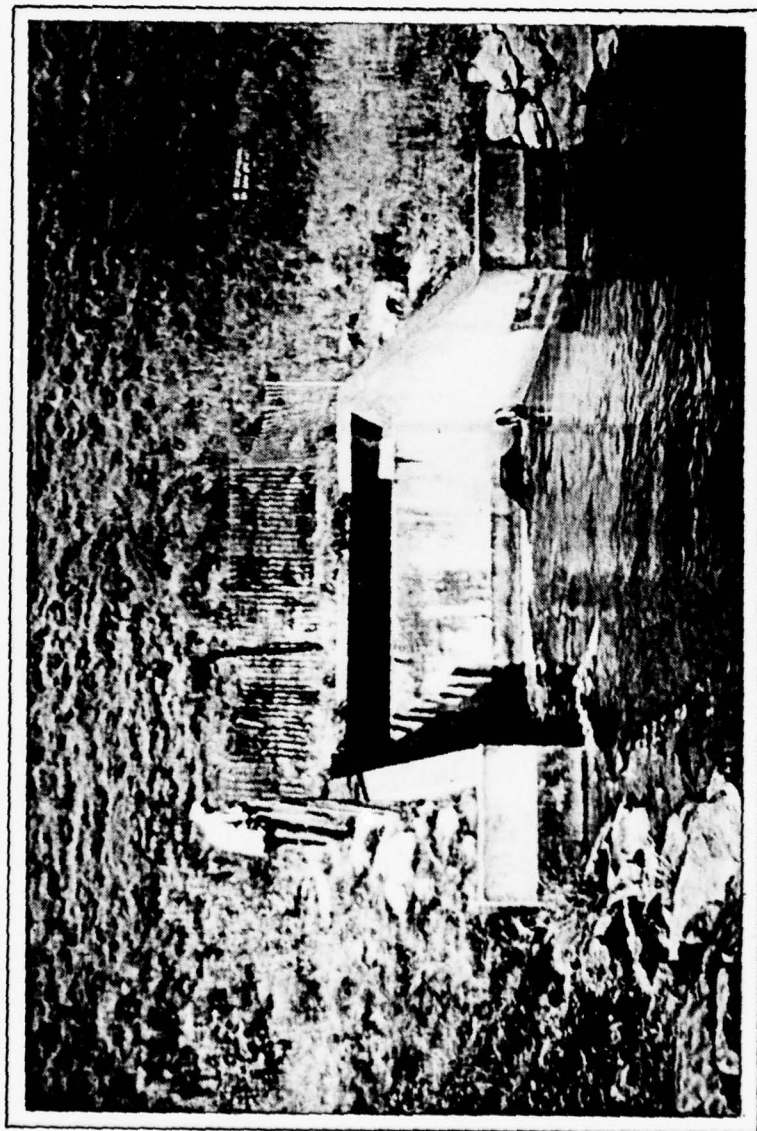
Soil Conservation Service representatives inspect these systems when reservoir water levels permit. The impact basin was inspected and no signs of concrete deterioration, spalling, cracking or other signs of structural movement were observed. It was assessed that this structure is in good condition, as is the riprap-lined channel below the impact basin.

PRINCIPAL SPILLWAY OUTLET STRUCTURE. NOTE  
SEEPAGE OUTLET PIPES FOR TOE DRAIN SYSTEM.

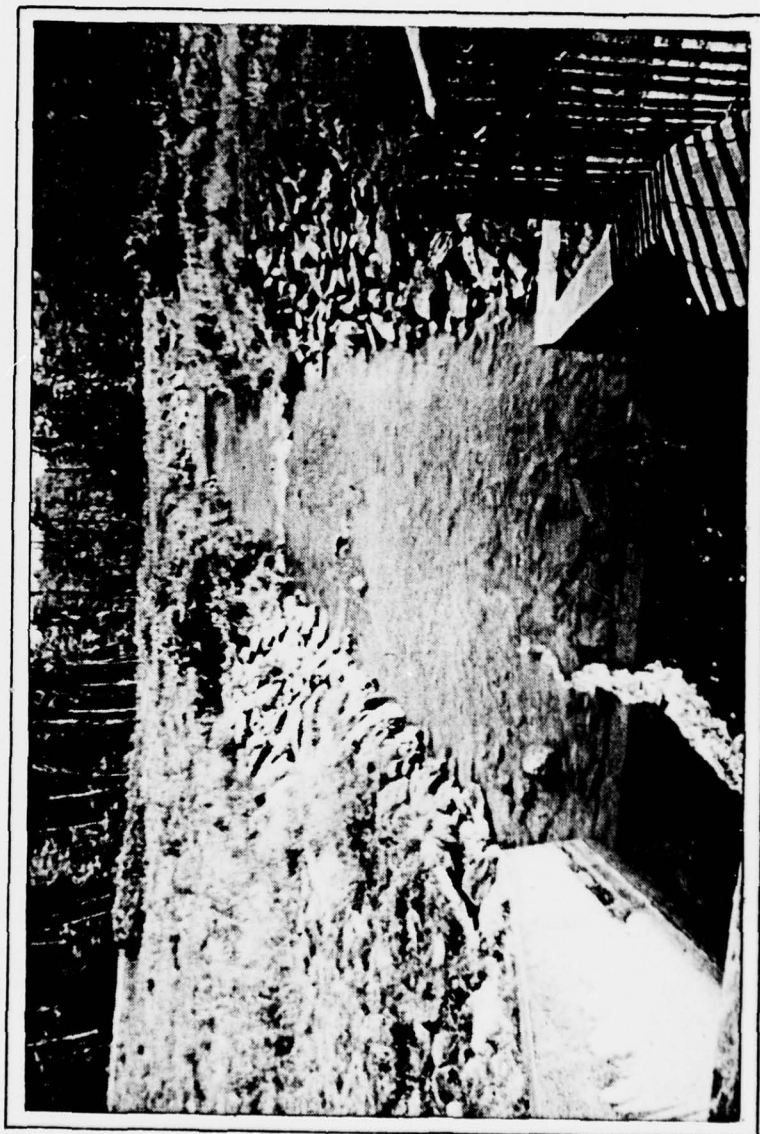
As discussed in Appendix B and in Section 3, marshy zones were noted on the left side of the principal spillway discharge channel, and further downstream along the channel. Discussions with Park representatives and a review of the records indicate that these seepage zones were noted before construction and that the dam was relocated 125 feet upstream to avoid the seepage. Although the reports indicate that these zones existed before construction of the dam, it is not known if the flow rates have increased since the reservoir has filled. The water should be collected and monitored for changes in rates or in turbidity.

VIEW OF PRINCIPAL SPILLWAY DISCHARGE  
CHANNEL. NOTE CATTAILS TO THE LEFT  
OF THE DISCHARGE CHANNEL.

a. Facilities. It is recommended that the marshy areas located to the west of the principal spillway discharge channel be graded and drained. This drainage should be periodically collected and checked for changes in flow rates or changes in turbidity.

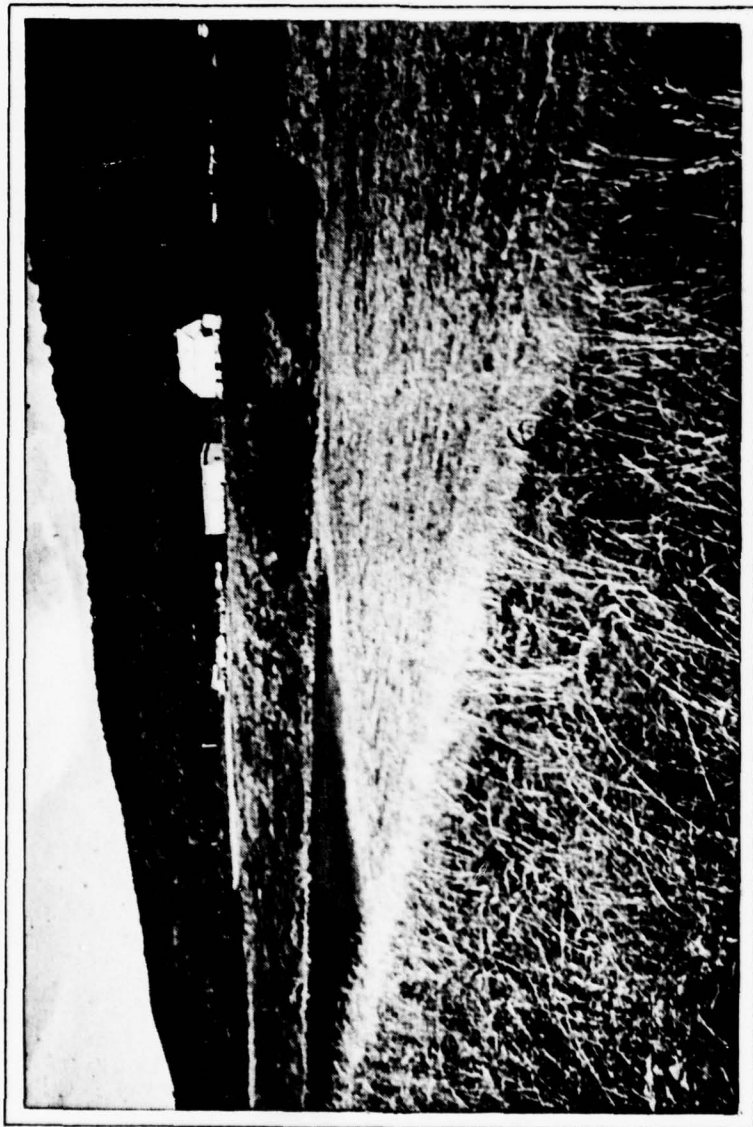
PHOTOGRAPH NO. 6

APPROACH CHANNEL	Good condition and well vegetated. Side slopes are stable.	
------------------	--	--

APPROACH CHANNEL TO EMERGENCY  
SPILLWAY.

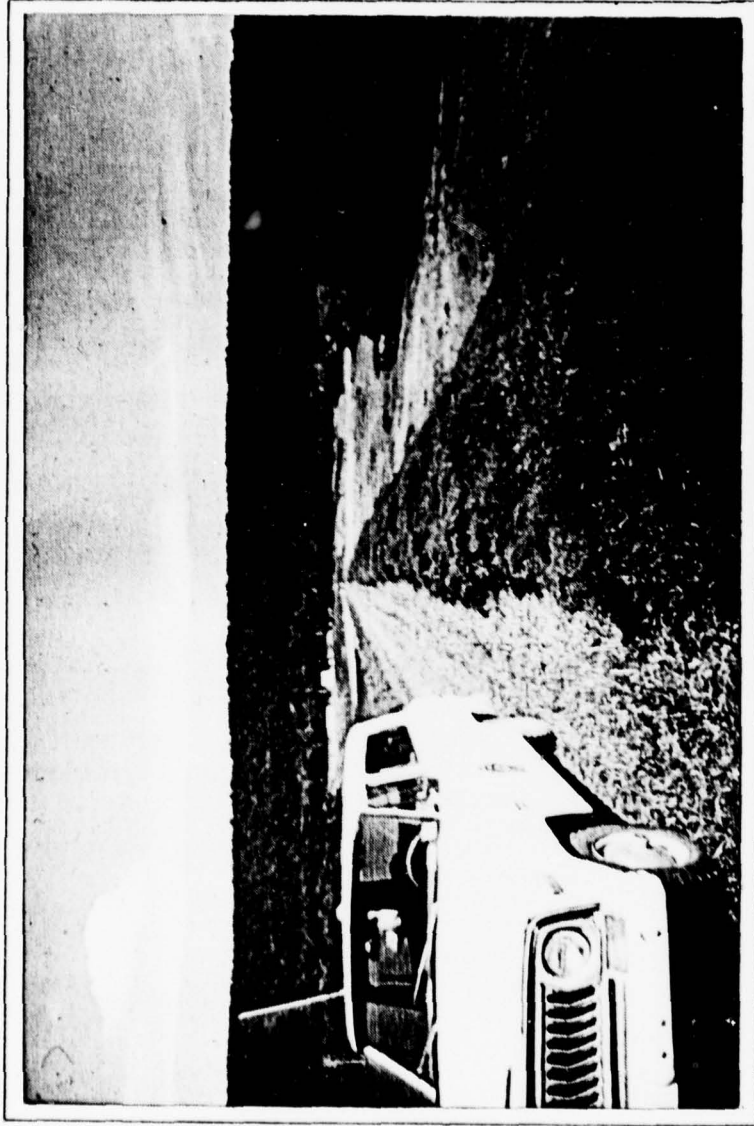
PHOTOGRAPH NO. 9

SLOUGHING OR EROSION OF  
EMBANKMENT AND ABUTMENT  
SLOPES      *None observed and downstream slope is covered with Crownvetch. Some  
minor erosion gullies less than 12 inches deep were uncovered below  
the vegetation but they do not present a current hazard to the dam.*

VIEW OF DOWNSTREAM SLOPE. NOTE  
DENSE COVER OF CROWN VETCH.

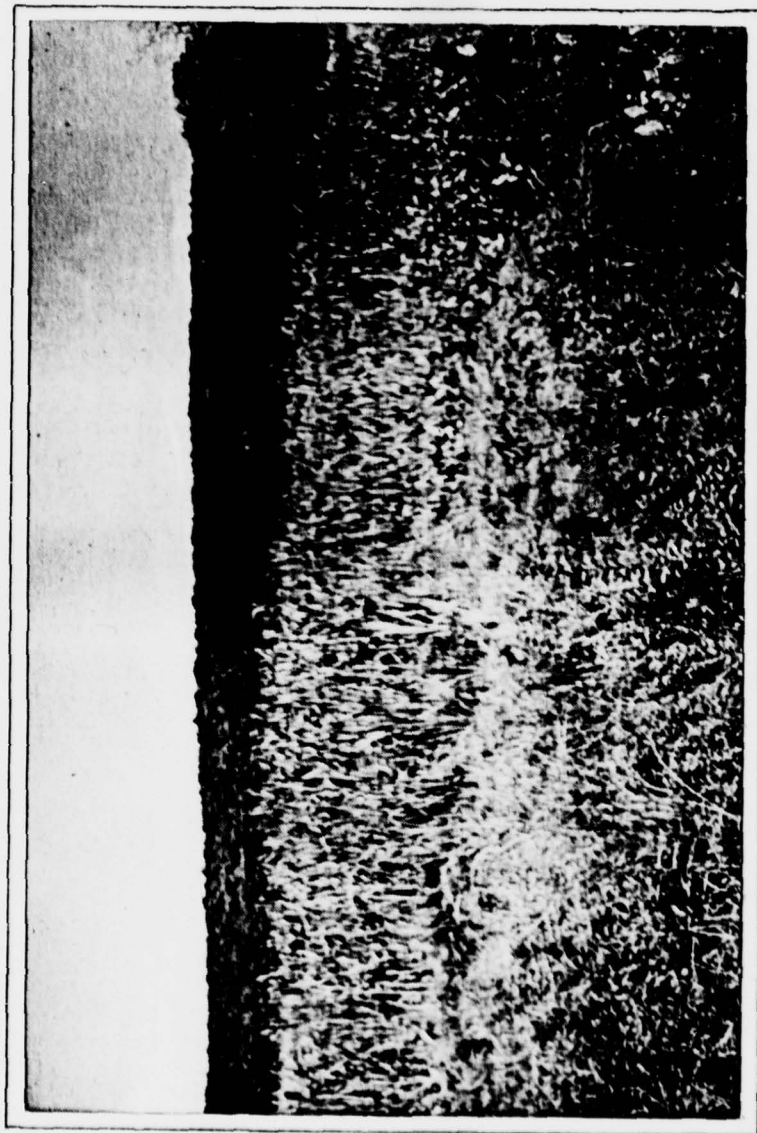
*See Sheet 5a. Wet zones were noted mostly on the left side of the discharge channel. Discussions with the Owners representative indicated that these seeps were there before construction and springs were in the foundation during grouting. Cattails and other vegetation changes denote the seepage areas. This seepage should be monitored for changes in rate.*

VIEW OF CATTAILS DENOTING SEEPAGE  
ZONES. SEE SHEET 5a, APPENDIX B  
FOR LOCATIONS.

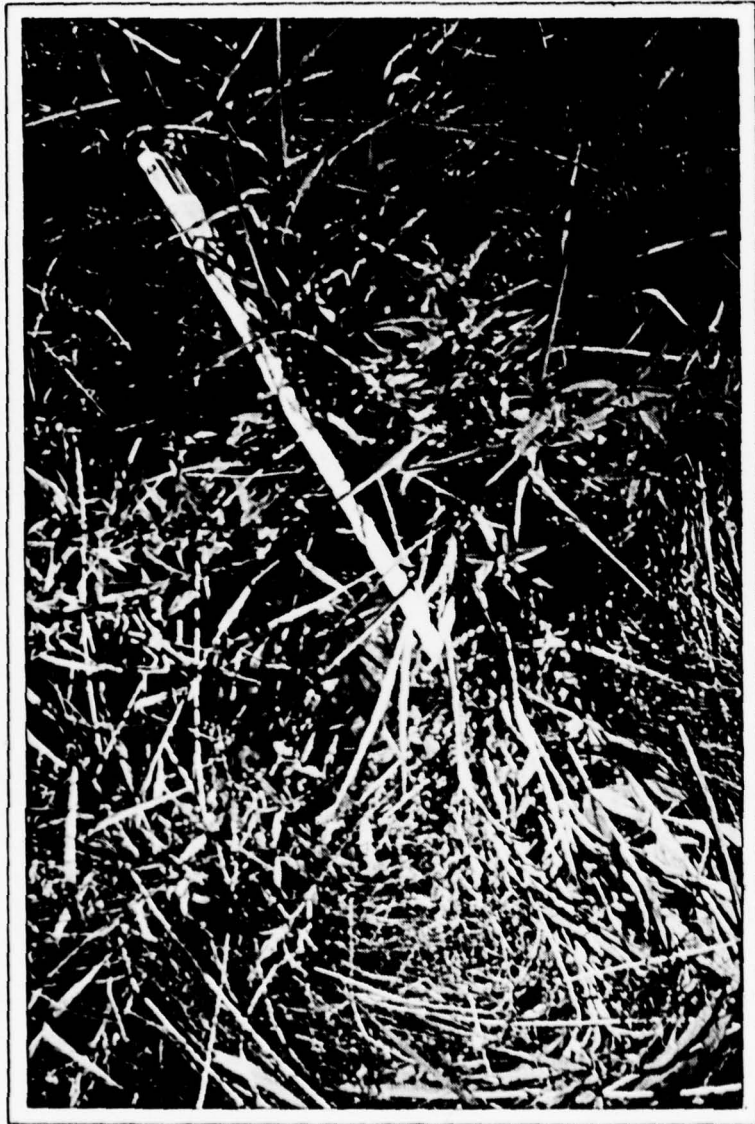
PHOTOGRAPH NO. 11

Further downstream, a zone of dead trees was noted. See sheet 5a of 11, Appendix B. The surrounding ground is marshy and presently contains some cattails. It is assessed, based on the visual inspection, construction photographs, and discussions with Park representatives, that this zone probably developed since filling of the reservoir. Therefore, this area should be carefully monitored for changes in flow rates or turbidity.

CLOSEUP OF SEEPAGE SOURCES WITHIN  
MARSHY AREAS DOWNSTREAM OF DAM.  
SEE SHEET 5a, APPENDIX B FOR  
LOCATIONS.

Similarly, the marshy area designated by the dead trees downstream of the emergency spillway should be monitored periodically. Although it is impractical to monitor flows in this area, it is recommended that the area be regraded and drained so the overall condition of the area can be periodically monitored for any gross changes in flow rates or turbidity. The area should be checked for concentrated flows which may lead to piping.

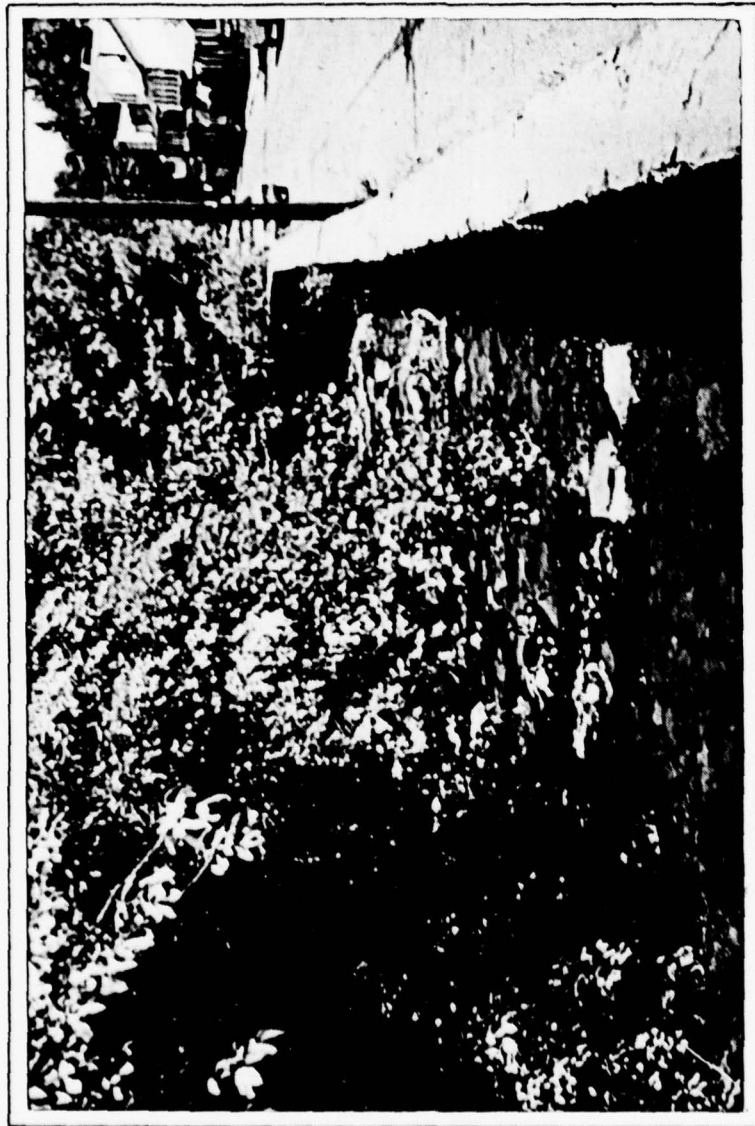
PHOTOGRAPH NO. 14

The flood plain below the dam is a swamp, unchanged from the original geologic and soils investigation report. The flood plain is approximately 200 feet wide. The channel banks are roughly 2 feet high, with side slopes ranging from near vertical to 1:1. Further downstream, Mauch Chunk Creek flows through the town of Jim Thorpe, which would be flooded in the event of high flows or failure of the dam. Photograph 14 of Appendix D shows a typical view of the Mauch Chunk Creek through Jim Thorpe, Pennsylvania.

TYPICAL VIEW OF MAUCH CHUNK CREEK  
AS IT PASSES THROUGH JIM THORPE,  
PENNSYLVANIA.
